**CANADIAN FORCES
FLIGHT SAFETY INVESTIGATION REPORT (FSIR)**

FINAL REPORT

FILE NUMBER: 1010-146493 (DFS 2-4)
DATE OF REPORT: 7 April 2006

AIRCRAFT TYPE: CH146 GRIFFON
DATE/TIME: 29 2255Z (1855 local) March 2004
LOCATION: 5 Wing Goose Bay
CATEGORY: "C" Category Accident

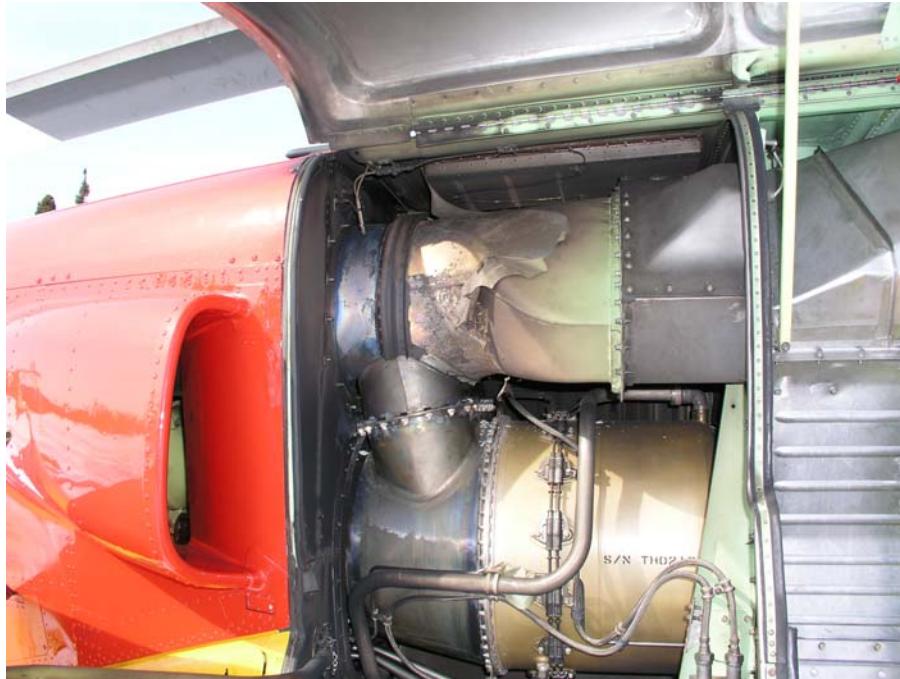
The inside of the engine compartment was covered by soot and burnt paint chips coming from the green primer paint of the exhaust duct cover. In addition, metal discoloration was present around the engine exhaust, the air bypass duct and the aft firewall.

An analysis of Health Usage and Monitoring System (HUMS) data revealed that the number two engine inter turbine temperature (ITT) reached a maximum value of 1,200°C for 24 seconds. The allowable maximum continuous temperature is 810 °C.

Photo 1: Number two Engine Compartment showing soot, burnt paint and discoloration.

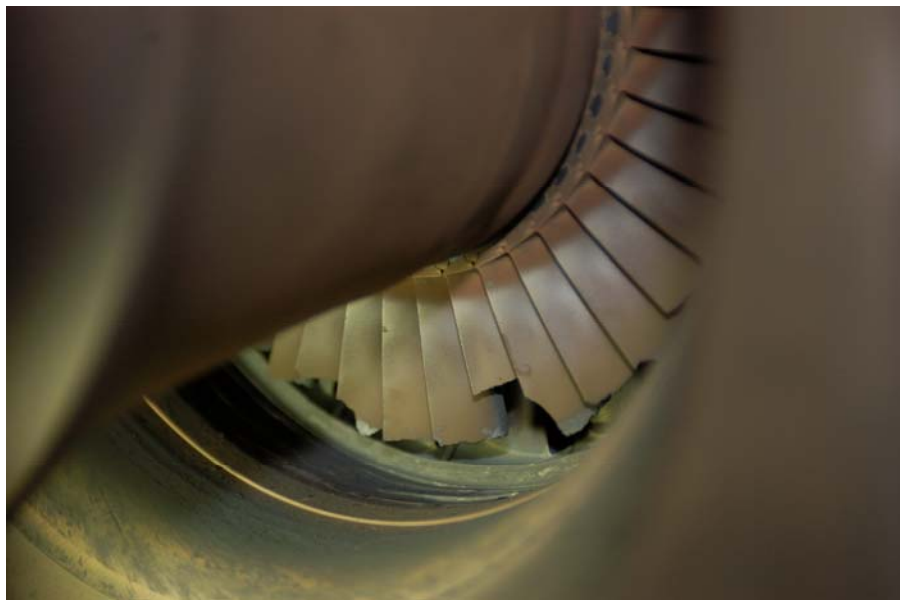
Once the cowlings were removed, an examination of the number two stage of the power turbine revealed that nearly all the turbine blades had lost 20%-50% of their tips. Numerous dents were also found on the inside of the exhaust duct. Dents and scratches were found on both tail rotor blades and on the leading edge of the vertical stabilizer. The air by pass duct was also warped and discolored at the exhaust section.

This accident was caused when the critical step of rolling the number two throttle to flight idle, prior to switching the number two engine governor to manual, was missed.

Photo 2: Number two engine, showing blade damage to the second stage of Power Turbine, as seen through the exhaust.
